# Manhole Inspection Summary

Manhole # S19K1\_009MH

Insp Date: **5/1/08 11:08 AM**

**Location** Address: **2501 w patapsco av**

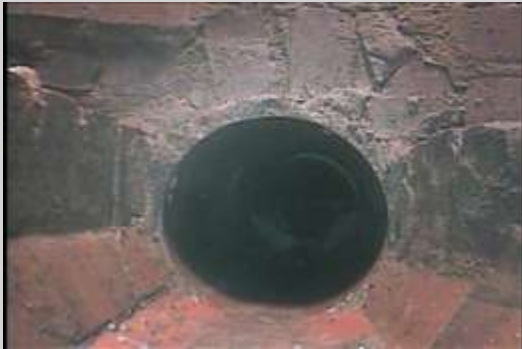
12 O'Clock Outflow

8 in. Circular Gravity Sewer  
Pipe Out @ 12 O'Clock

Pipe Height: **8.4** (in.) Rod and Bar (Angled)

Pipe Material: **Clay** ☐ Pipe Lined

Invert Depth: **7.60** (ft.) Flow Characteristics: **None**

Deposits: ☒ None ☐ **Mud** ☐ Sludge ☐ Debris ☐ Grease

Infiltration: **None** Pipe Seal Cond: **Sound**

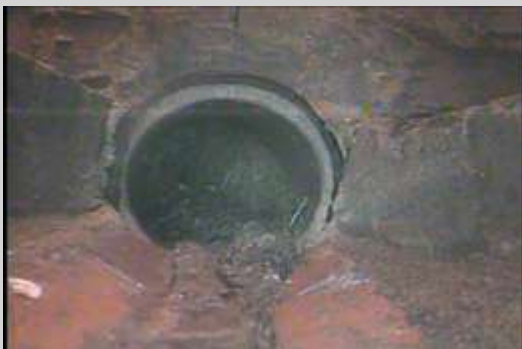
5 O'Clock Inflow

6 in. Circular Gravity Sewer  
Pipe In @ 5 O'Clock

Pipe Height: **6** (in.) Rod and Bar (Angled)

Pipe Material: **Clay** ☐ Pipe Lined

Invert Depth: **7.20** (ft.) Flow Characteristics: **None**

Deposits: ☐ None ☒ **Mud** ☐ Sludge ☐ Debris ☐ Grease

Silt Depth: **2** (in.) Deposits Extent: **Medium**

Infiltration: **None** Pipe Seal Cond: **Sound**

Connects To: **House connection / Service line**
